**EXPERIMENTAL INVESTIGATION AND MODELING OF  
CONCRETE STRUCTURES EXPOSED TO MOLTEN SULFUR**

A Dissertation Presented to the  
DEANSHIP OF GRADUATE STUDIES

**KING FAHD UNIVERSITY OF PETROLEUM & MINERALS**

**CIVIL ENGINEERING**

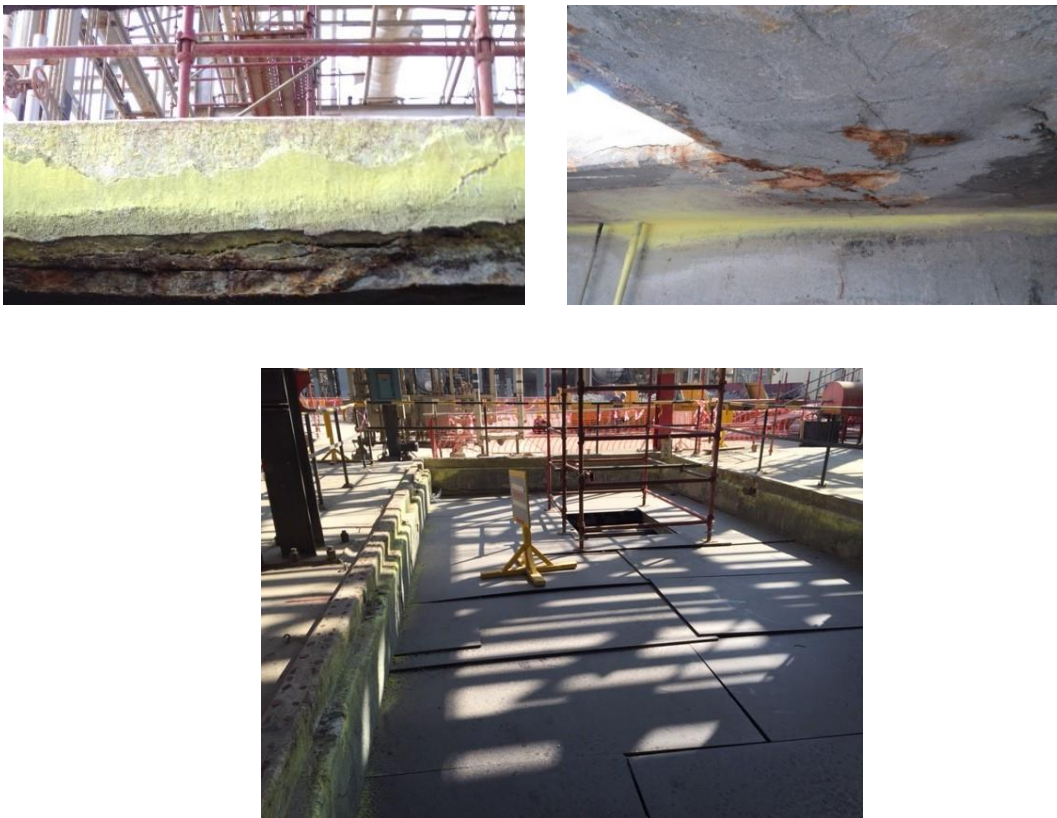
**Figure 1-1: Deterioration of the roof of a concrete sulfur pit structure**

Investigation of a typical sulfur pit (Figure 1-1) was conducted including, visual inspection, carbonation depth, chloride and sulfate content, compressive strength, corrosion potential. Extensive cracking in the upper part of the walls and the bottom of the roof slab have been noticed along with stains and sign of corrosion. Delamination of the concrete cover and Spalling has been noticed at 60% of the roof soffit. Chloride quantities found were within or lower than threshold ( $<0.08\%$  by weight of cement). The depth of carbonation measured with a pH color indicating solution (Phenolphthalein) on a sample core, revealed significant carbonation covering almost the full depth of the core.

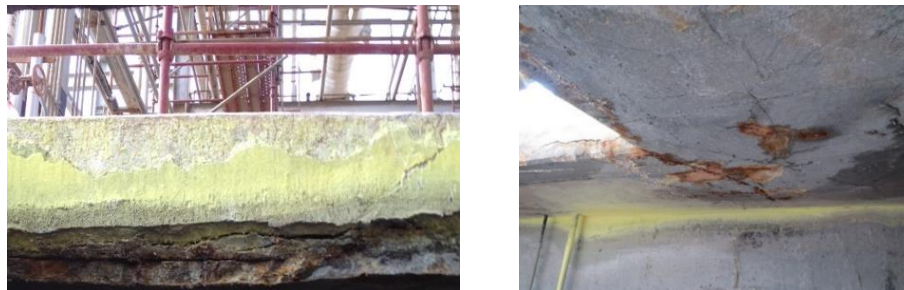
**Figure 2-3: Deterioration of the roof of a concrete sulfur pit structure**

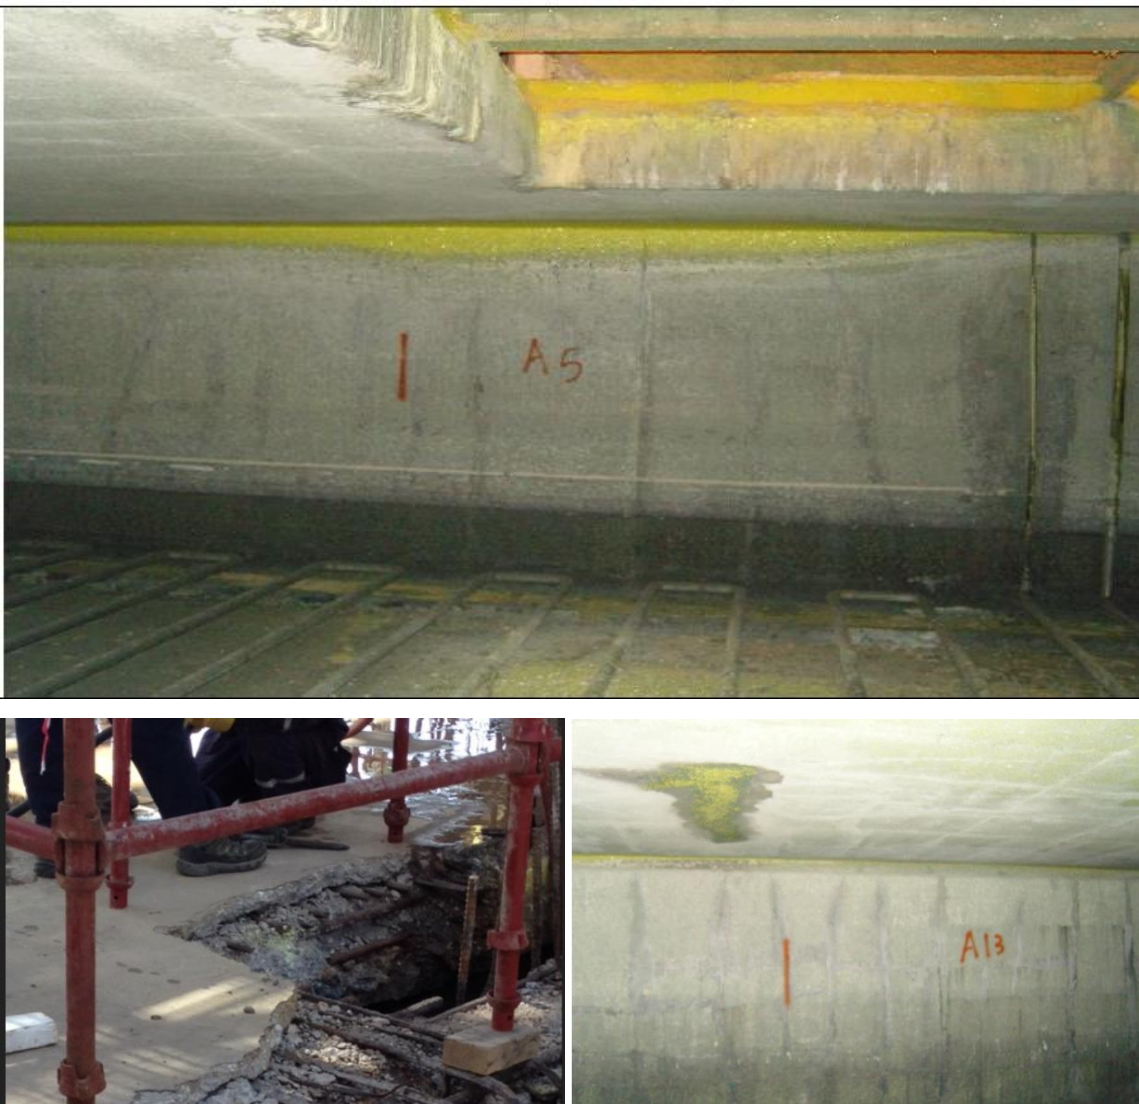
**Figure 3-3: SP1 Delamination of the roof slab due to reinforcement corrosion and vertical parallel cracks throughout the walls**

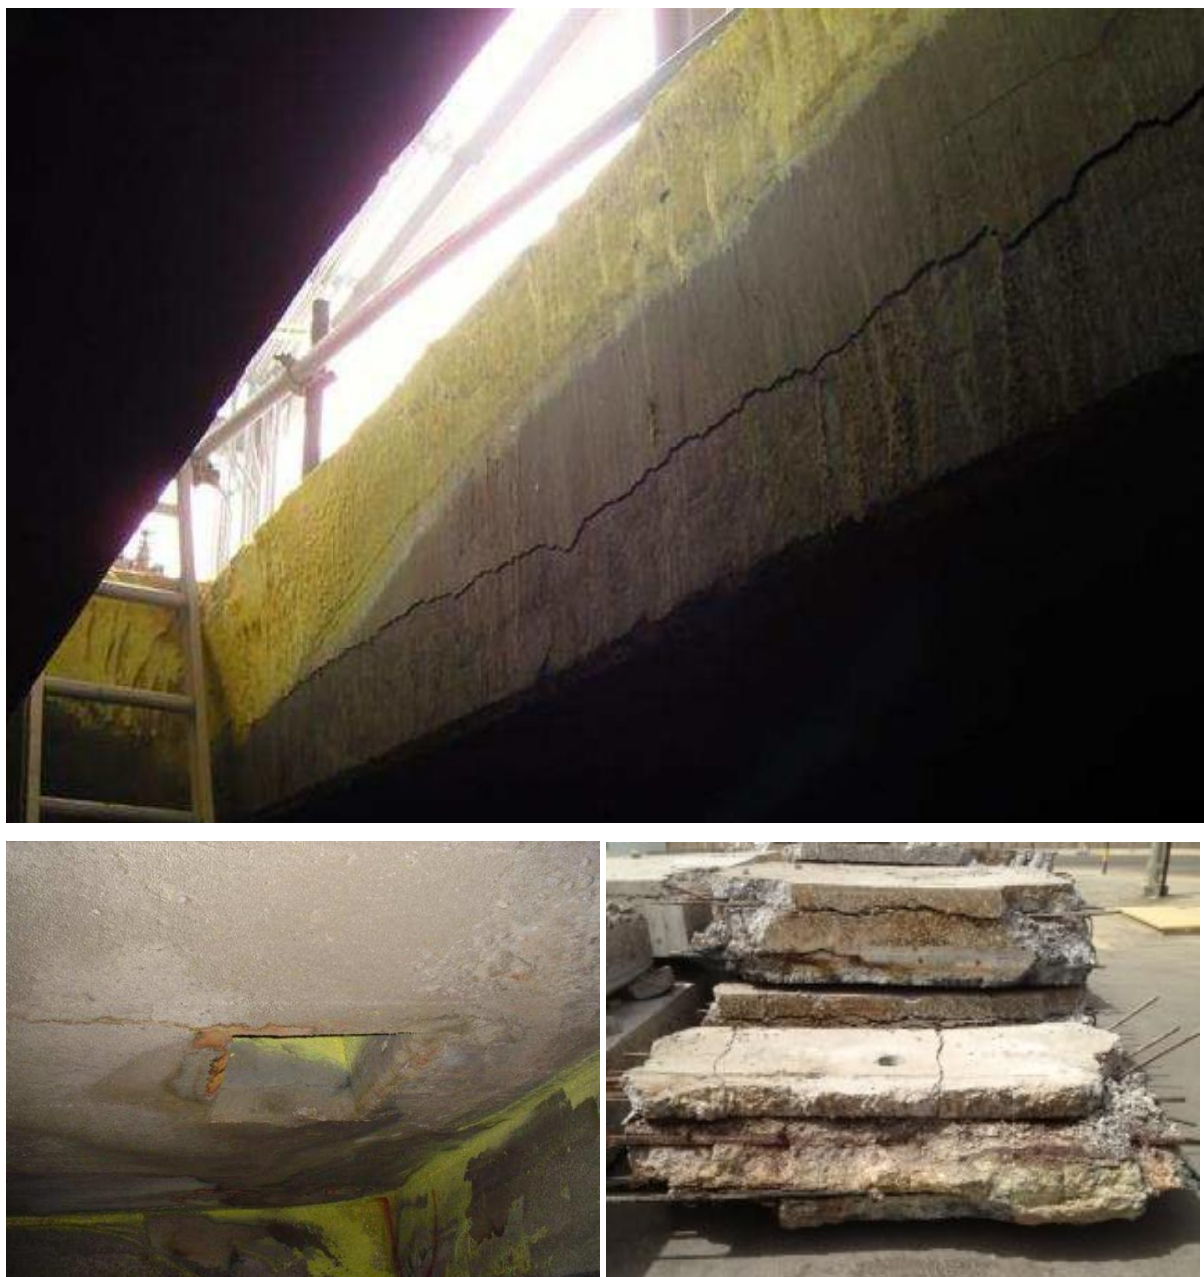
**Figure 3-4:SP2 Cracking, delamination and bulging at the roof soffit.**

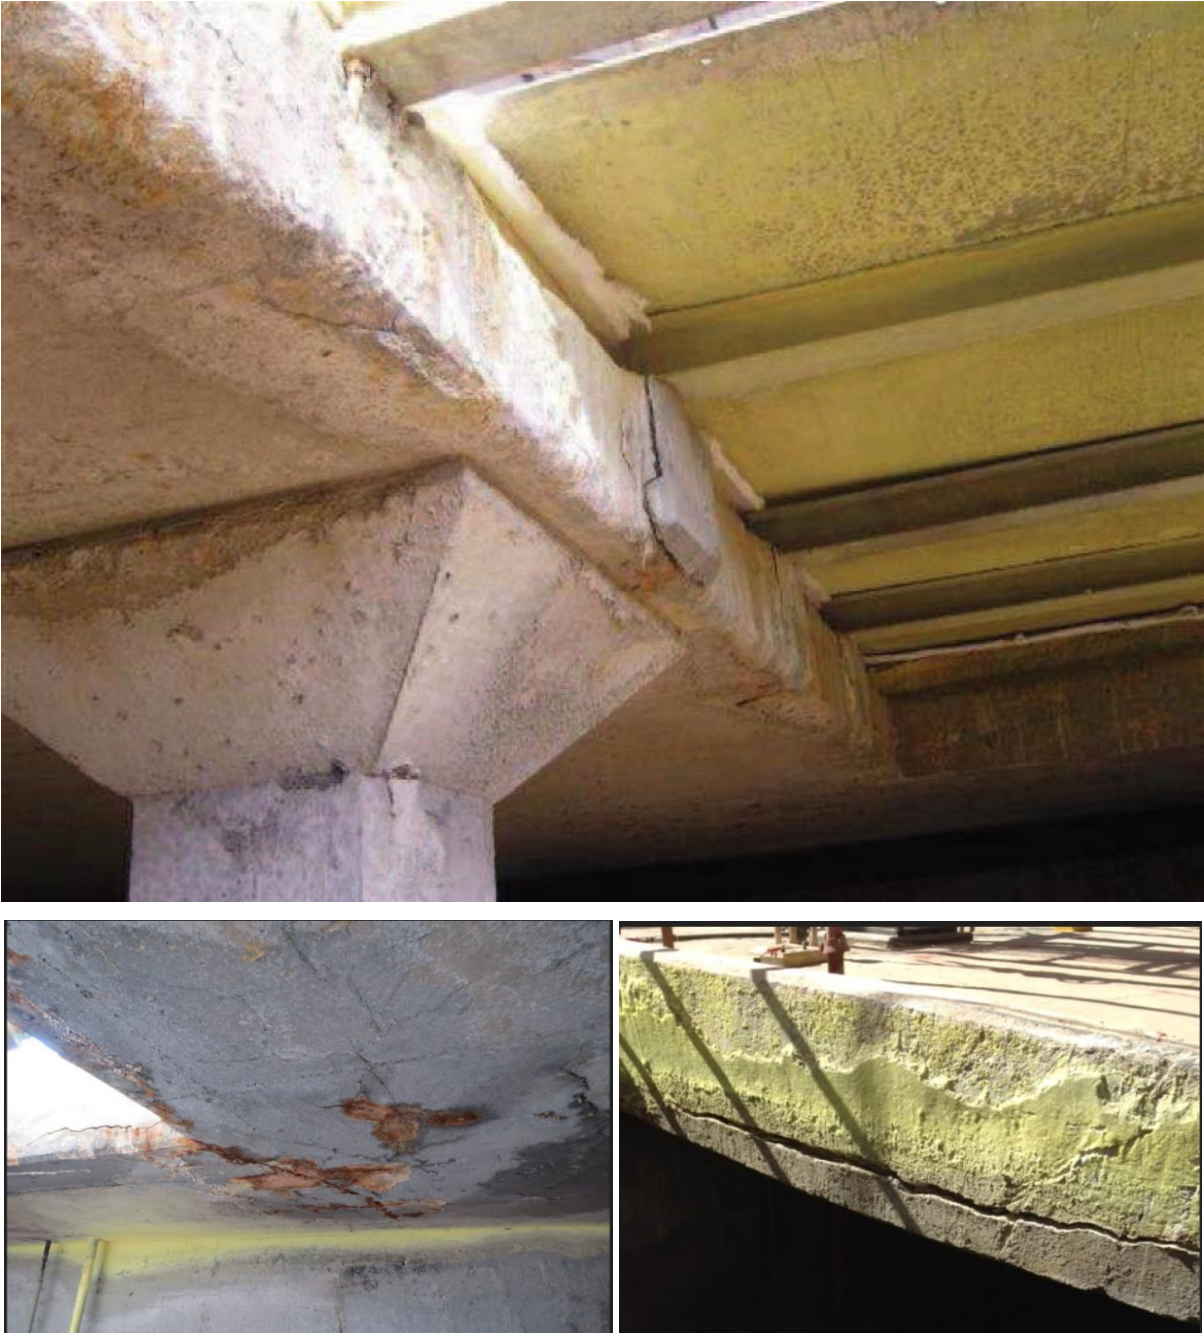
**Figure 3-5: SP3- Delamination of the roof slab due to reinforcement corrosion**

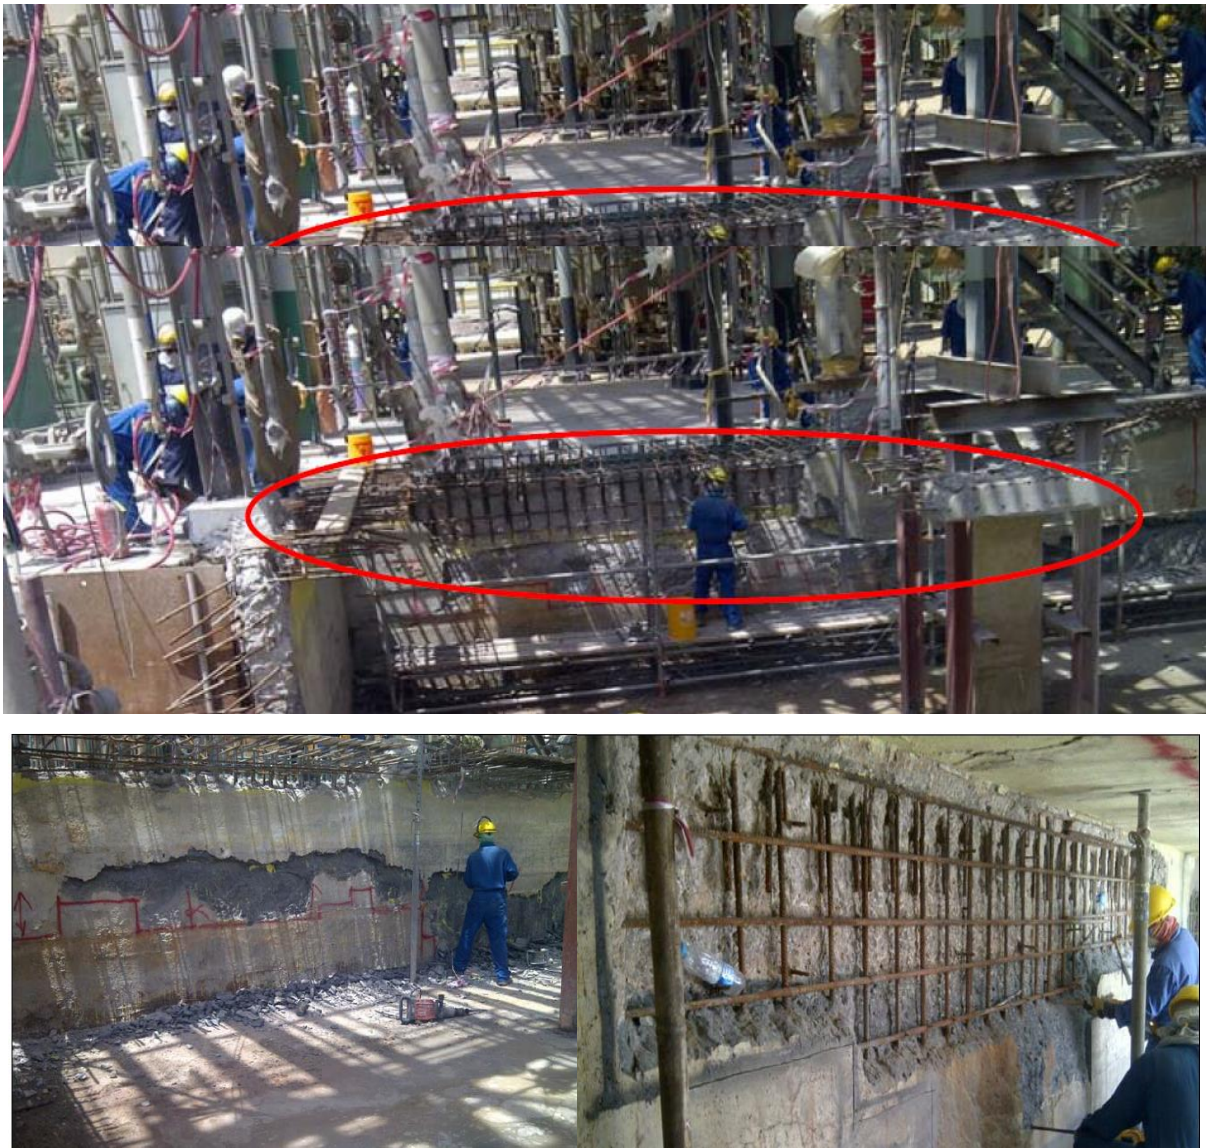
**Figure 3-6: SP4 Sever corrosion of the reinforcement specially vapor zone.**

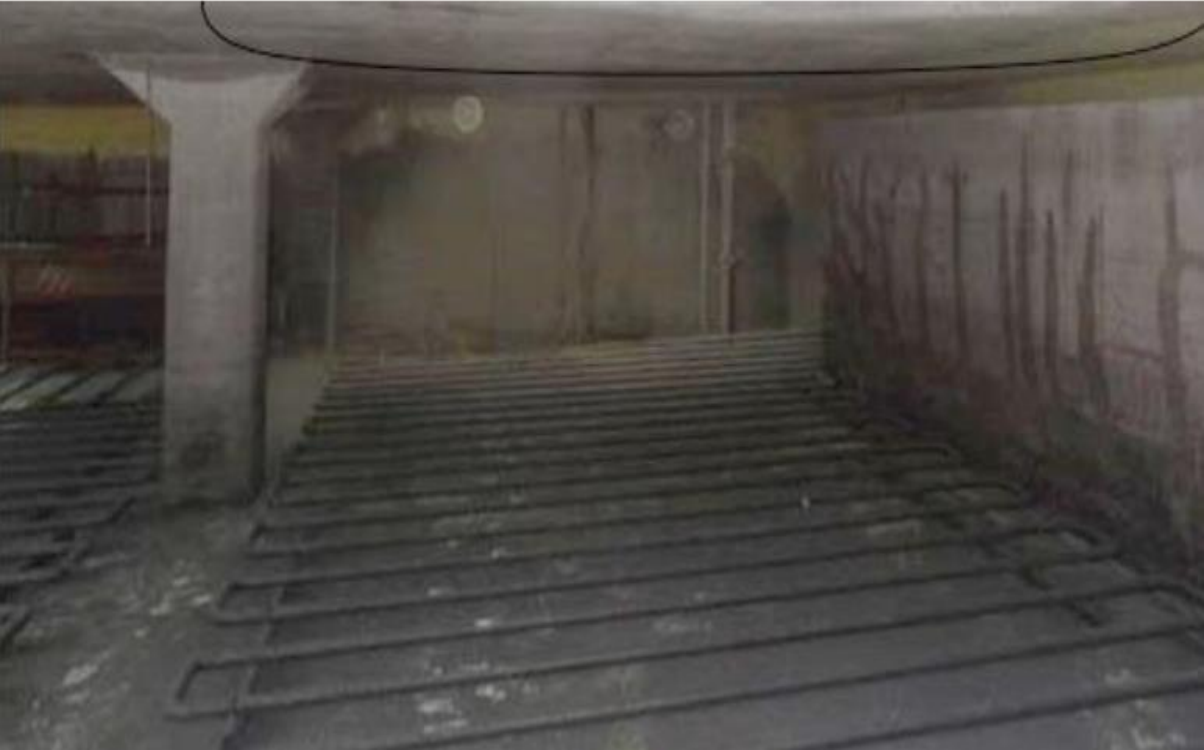
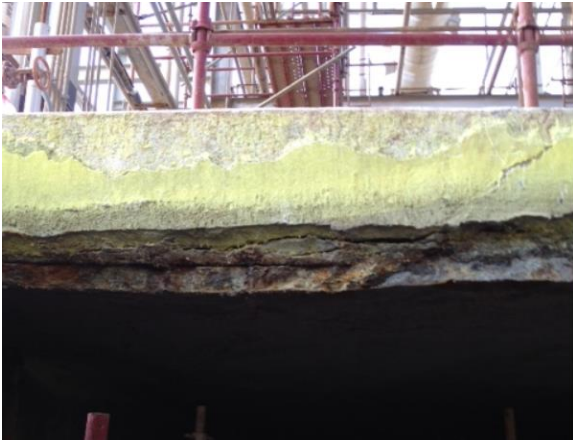
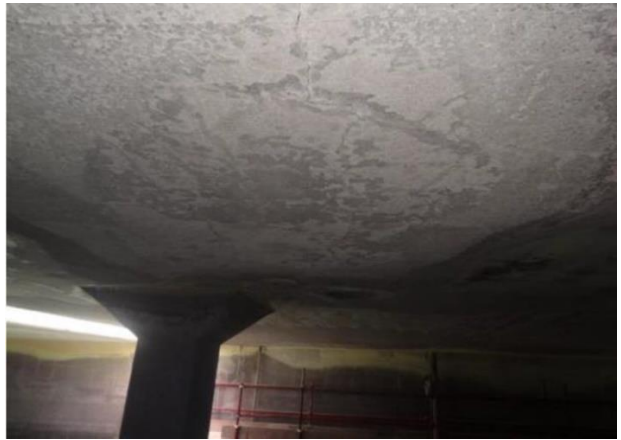
**Figure 3-7: SP5 Zoom-in view of the bulging of underside of roof slab due to delamination of concrete.**

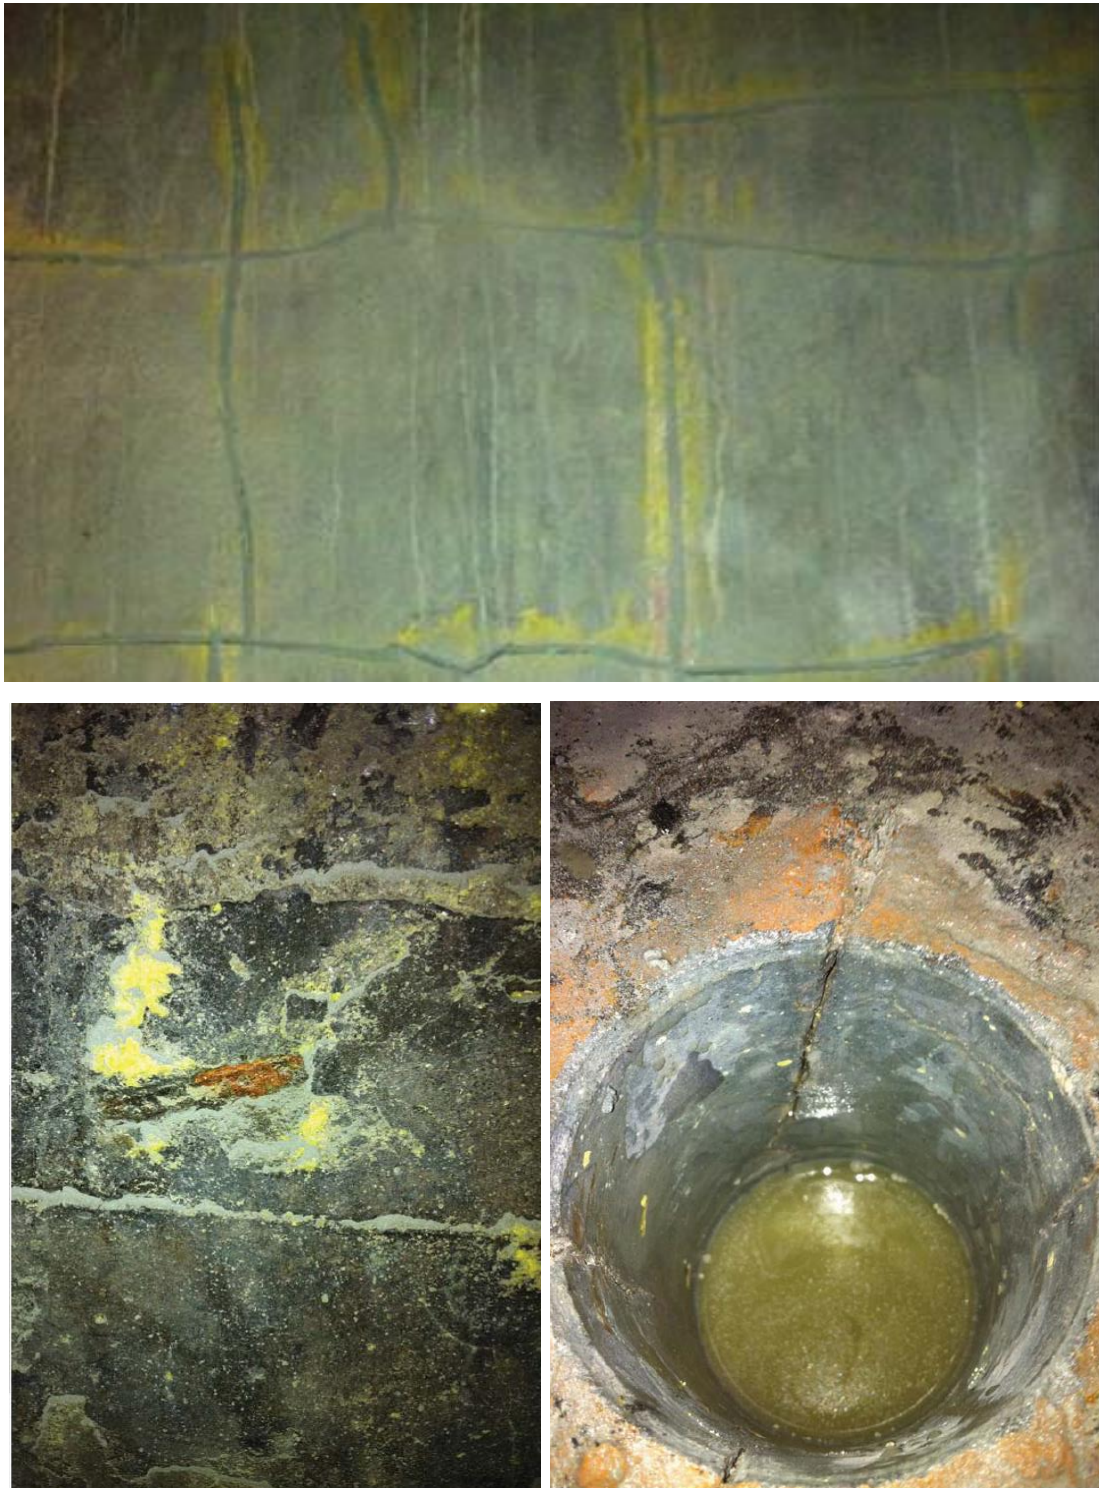
**Figure 3-9: SP7 Note the horizontal and vertical cracking extending beyond the top layer of reinforcing steel.**

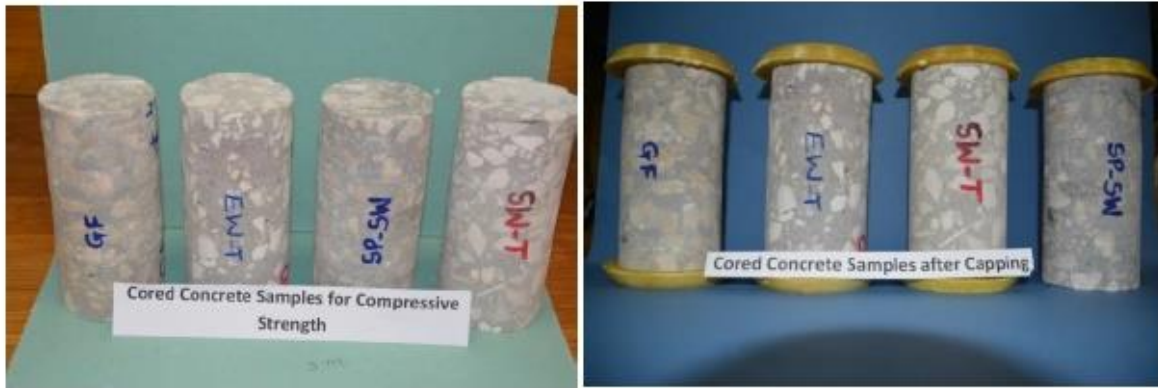
Figure 3-12: Cored concrete samples after saw cutting and capping.

Compressive strength of cored samples was determined according to ASTM C 39. Prior to the testing samples were saw cut on both sides to make the surface smooth capped with the sulfur as illustrated in Figure 3-12. Compressive strength of core samples obtained from the wall, roof slab and foundations are summarized in Figure 3-13: Compressive strength of cores obtained from the walls -3.16.

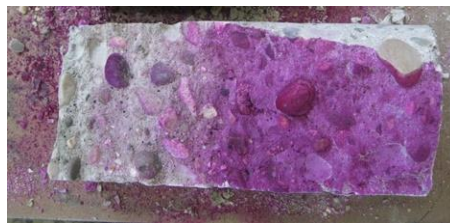
**Figure 3-22: Phenolphthalein indicator on the freshly cut concrete surface**

pH of concrete was measured by spraying phenolphthalein indicator on the freshly cut concrete surface. The area on the surface shows no color change has a pH less than 10.0 while the areas with higher pH exhibit pink color (Figure 3-22). The depth from the surface of the area showing no color change was measured and reported depth in millimeters. The test was done on the surface of freshly cored concrete specimens on the field immediately after retrieving.

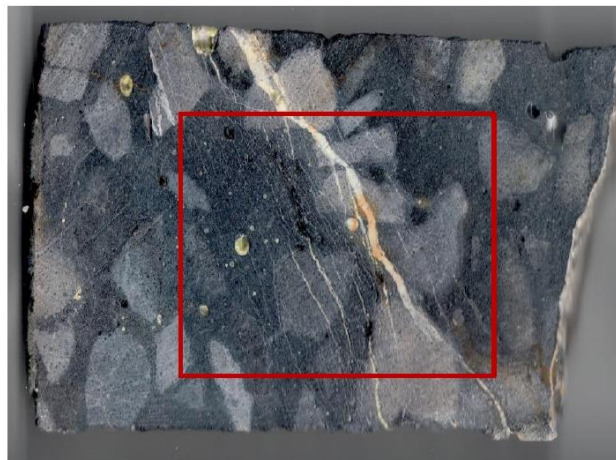
**Figure 3-29: View of the core extracted from the West wall of SP5 showing multiple cracks**

The petrographic examination of concrete shows nominal 19mm, crushed limestone/dolomite coarse aggregate and quartzitic sand fine aggregate, bound by a probable Portland-type cement matrix. It is likely that the dark color of the cement matrix is the result of chemical alteration and some degree of polymerization. The coarse aggregate particles, particularly those near the outer surface (those within the outer 100 mm) exhibit internal stress cracks and also regular sulfur infilled cracks. The concrete exhibits multiple cracks and air voids infilled with sulfur that run sub-parallel to the outer surface. These cracks run through the cement matrix and coarse and fine aggregate particles. The cracking, could be a combination of sulfate attack, extreme temperature gradient and stresses, and cracks resulting from reinforcement corrosion. The outer surface of the concrete exhibited a surface coating that appears largely intact. The inner (fracture) end surface of the core exhibited a white sulfur coating.

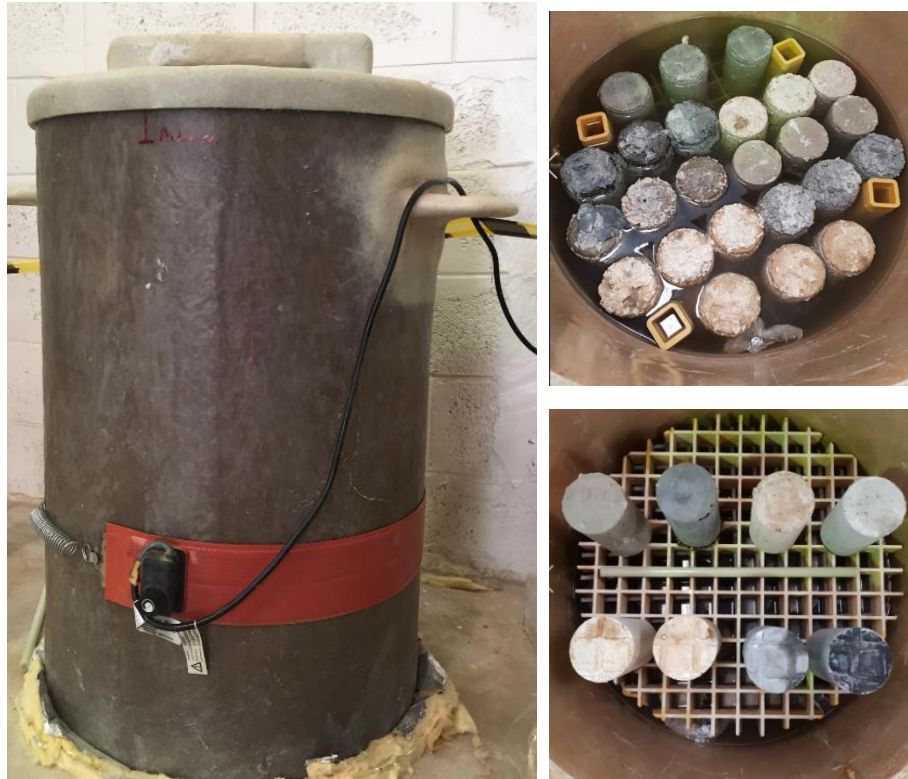
**Figure 4-15: Experimental Setup for exposing concrete samples to sulfuric acid at elevated temperature**

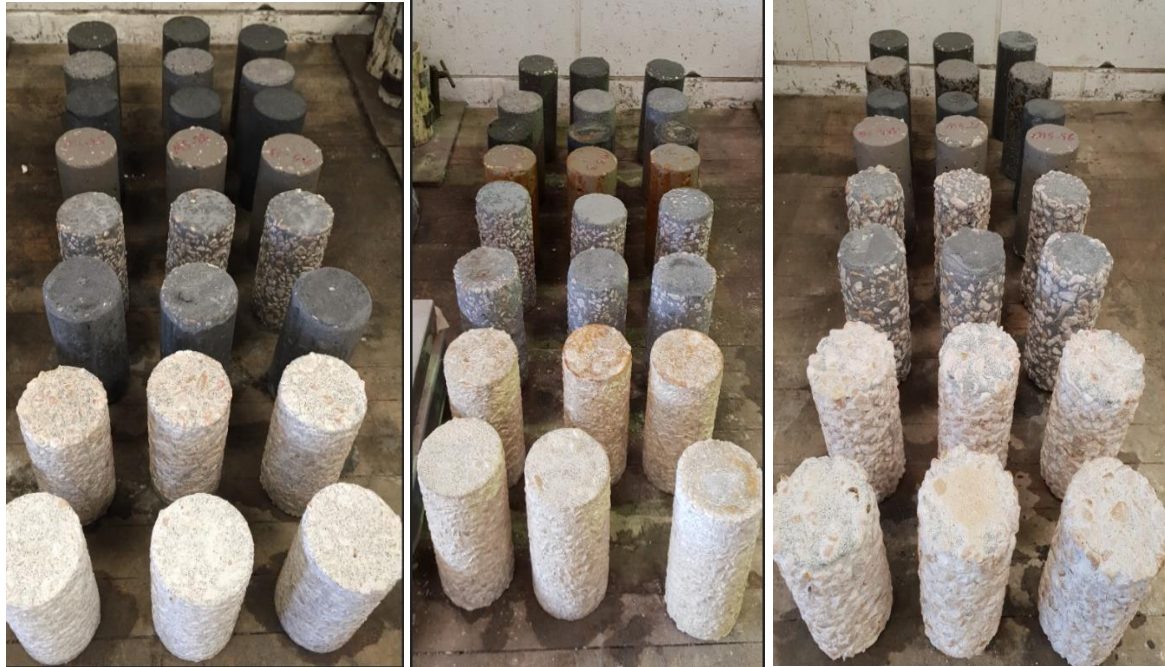
**Figure 4-19: Concrete Specimens retrieved from the acid exposure and brushed to remove the loose outer layer. 2, 4 and 8 weeks.**

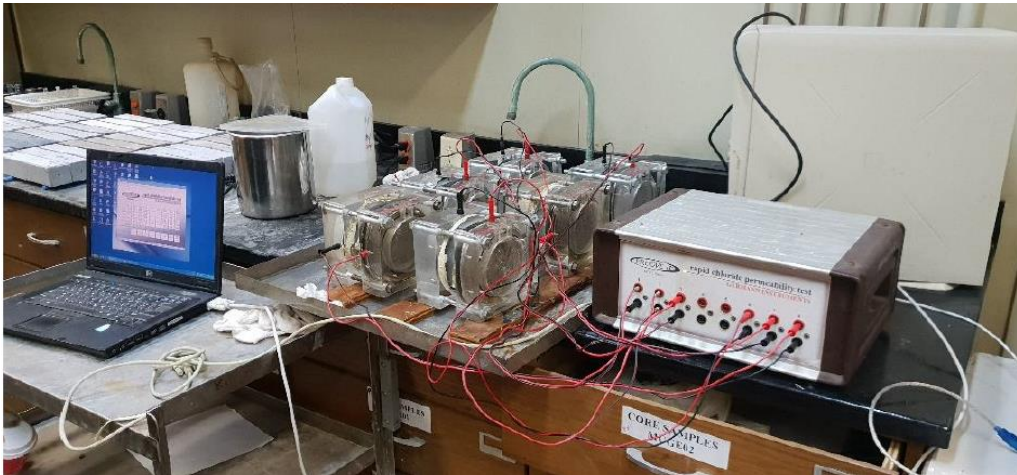
**Figure 4-24: Setup measure Rapid Chloride Permeability (RCPT)**

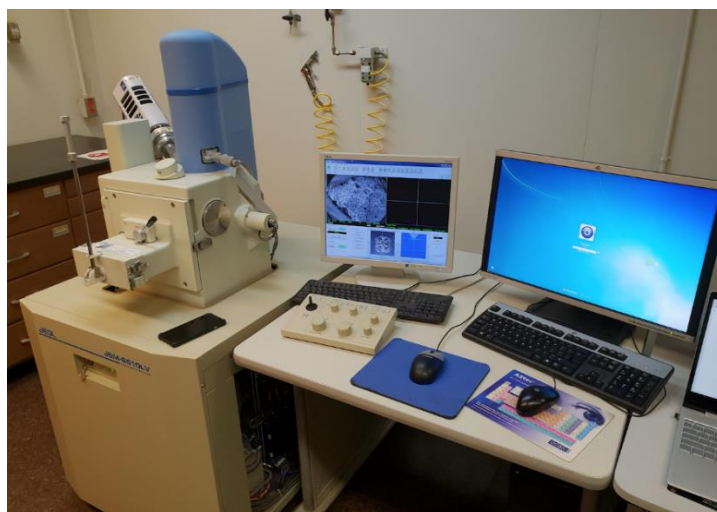
**Figure 4-27: SEM-EDS JOEL JSM-6610LV – KFUPM\_RI**

SEM and EDS provide magnified images and morphology of the microstructure in addition to quantitate estimation of the elemental composition such as Ca, Fe, Na, Si and Al. The observations were carried out through microscope JOEL JSM-6610LV (Figure 4-27). Analysis was conducted on fresh fractured surface after coating with Au.

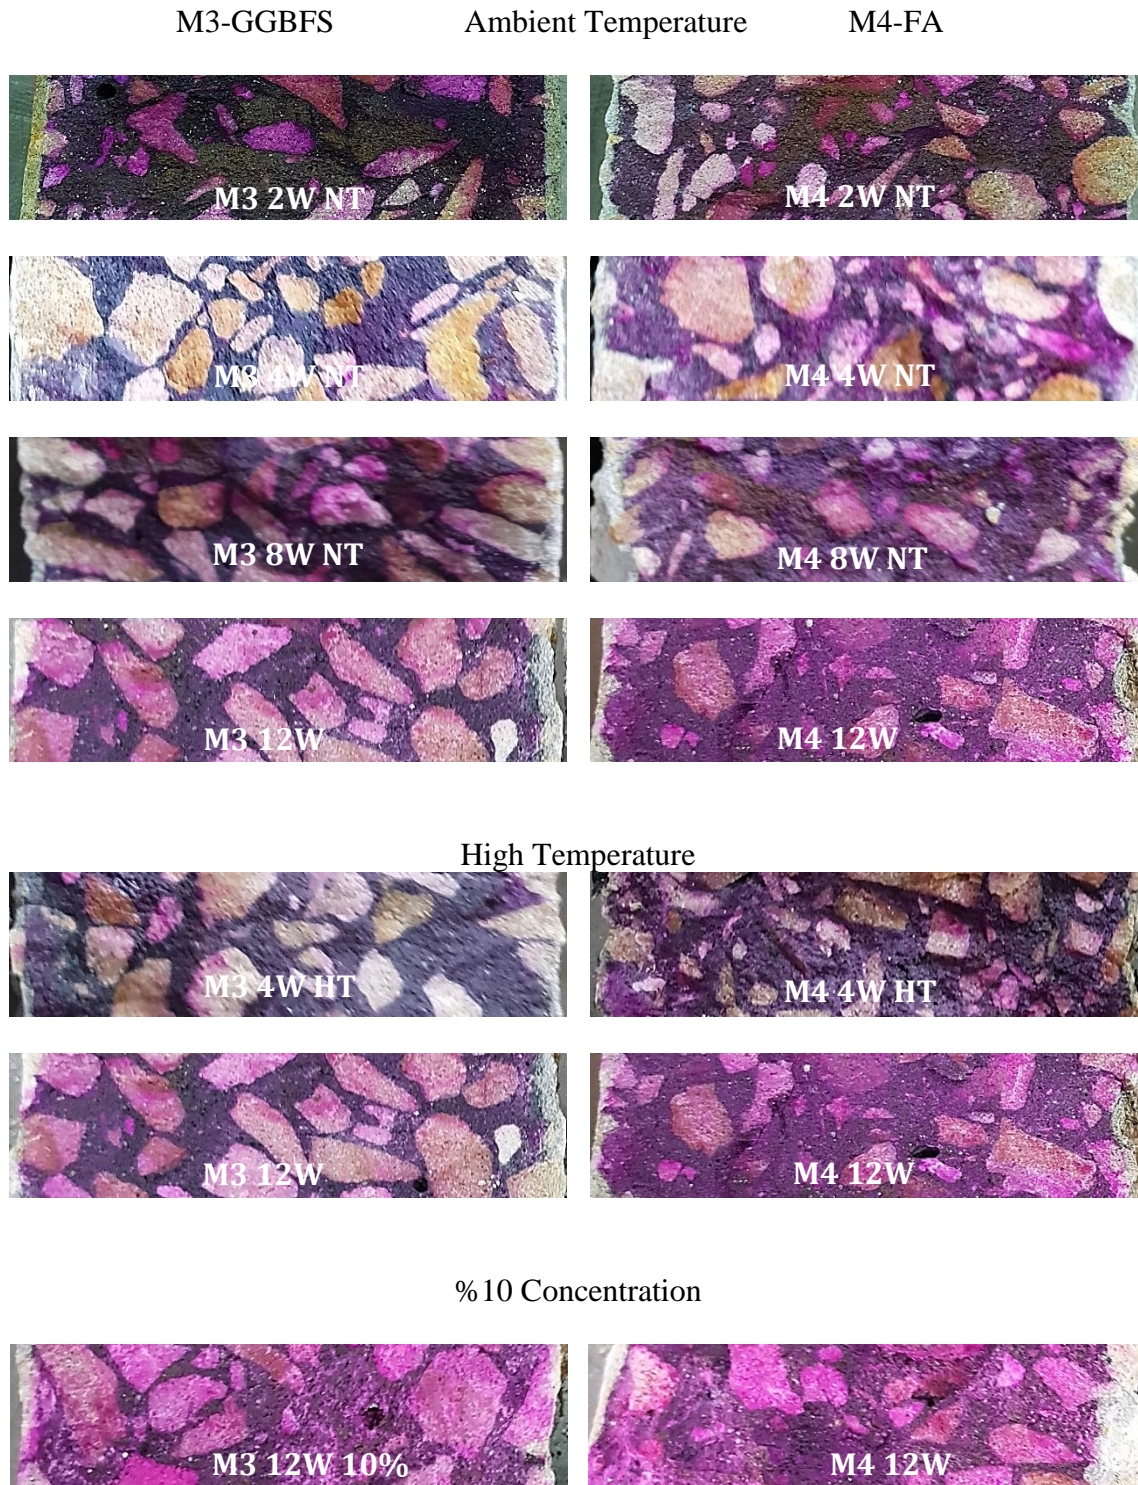
**Figure 5-60: Corroded layer of concrete sample M3(left) and M4 (Right) after 2, 4, 8 and 12 Weeks at Ambient and high Temperature and at %10 concentration exposure indicated by sprayed phenolphthalein**
